Xbox 360 E RF Module Replacement

Replace the RF module of your Xbox 360 E.

Use this guide to replace the RF module in your Xbox 360 E.

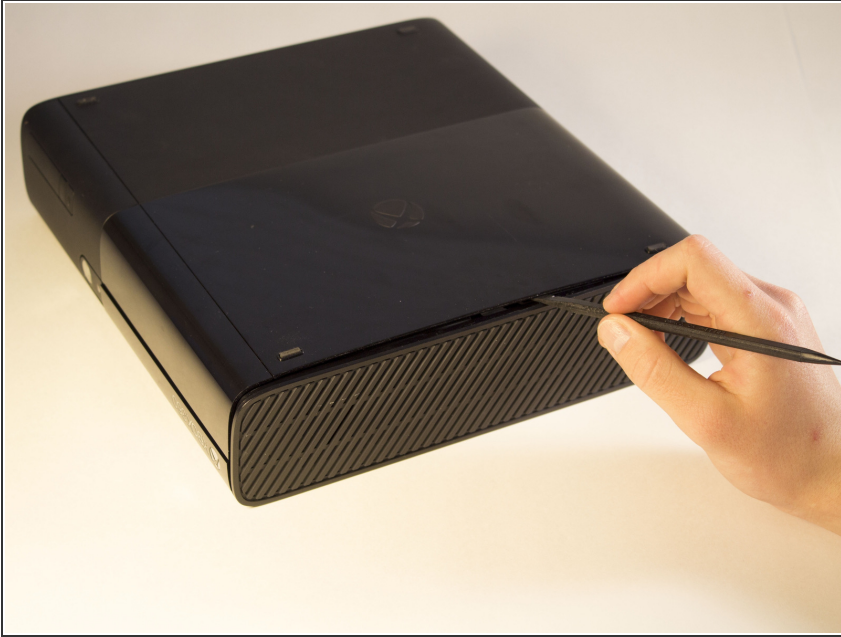
Step 1 — Top Panel

- Push the [Spudger](#) into the crevice between the grated top panel of the Xbox and the bottom body with the rubber feet.
- Pull back on the spudger like a lever, keeping it pressed firmly into the crevice.

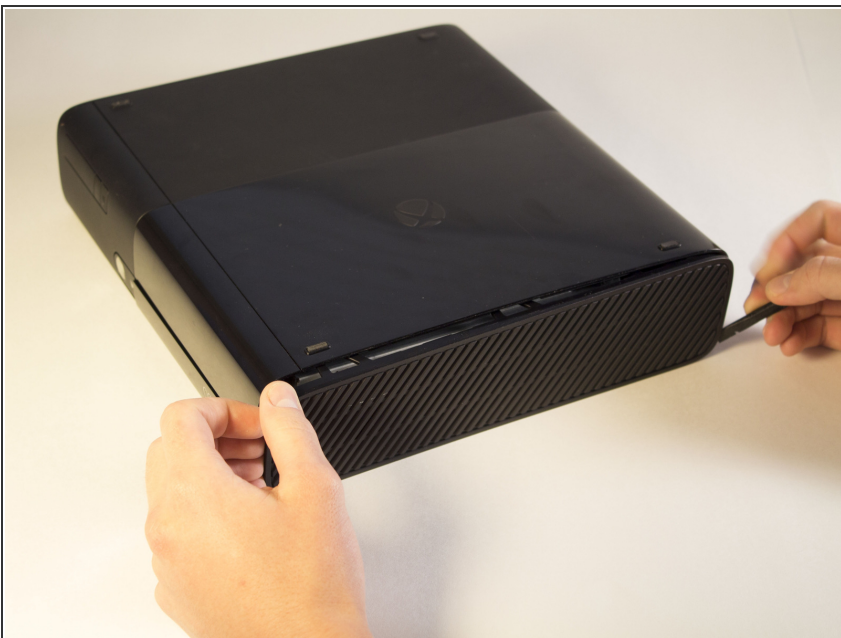
Step 2

- Slide the spudger along the separation you have created between the grated panel and the bottom body of the Xbox.
- Periodically pull back on the spudger like a lever, keeping it pressed firmly into the crevice.

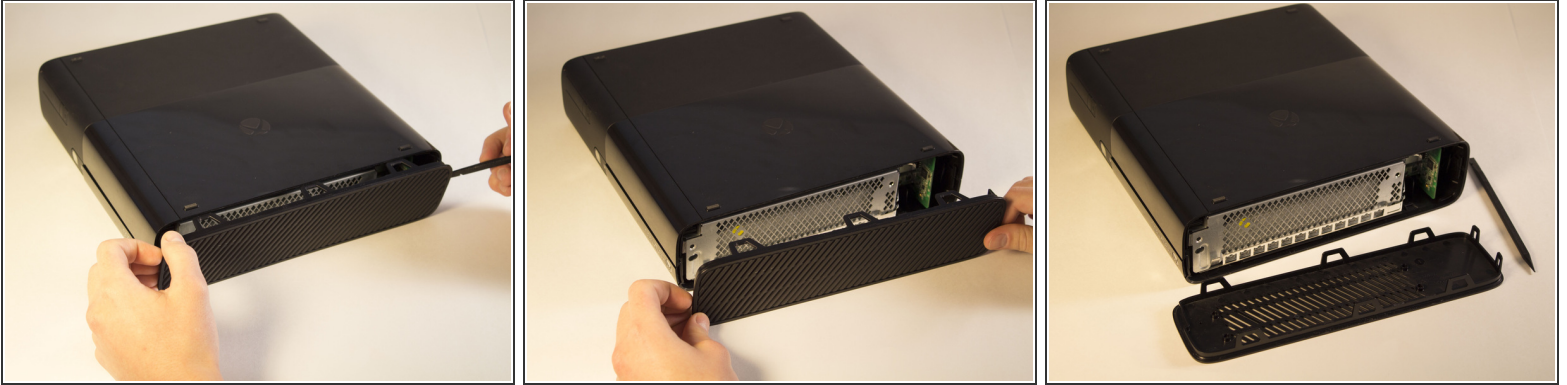
Step 3

- Continue sliding the spudger along the perimeter of the left grated face of the Xbox.
- Pull the top panel off.

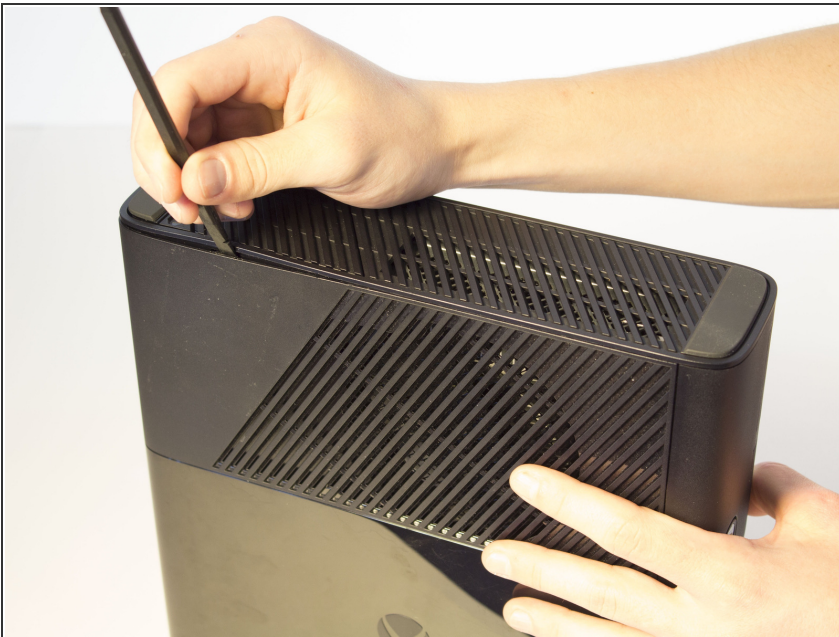
Step 4 — Bottom Panel

- Push the spudger into the crevice between the right grated face and the top body of the Xbox. It's easier to begin away from the vent.
- Pull up on the spudger like a lever, keeping it pressed firmly into the crevice.

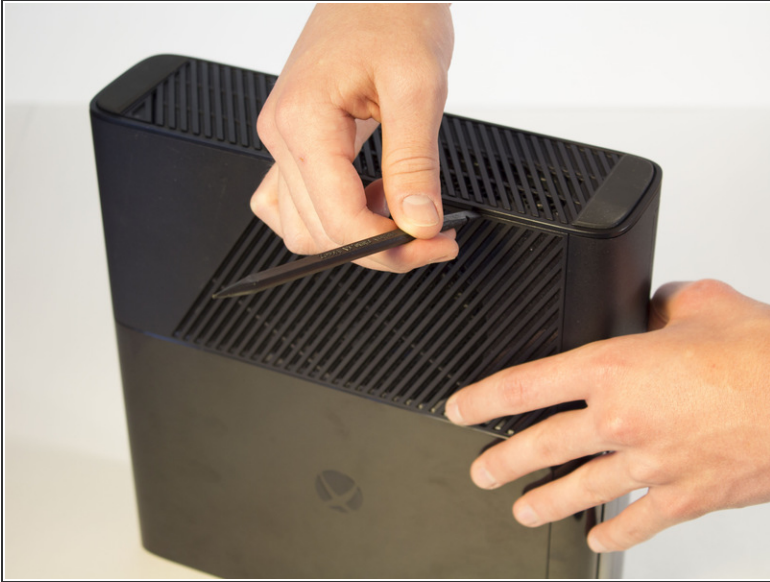
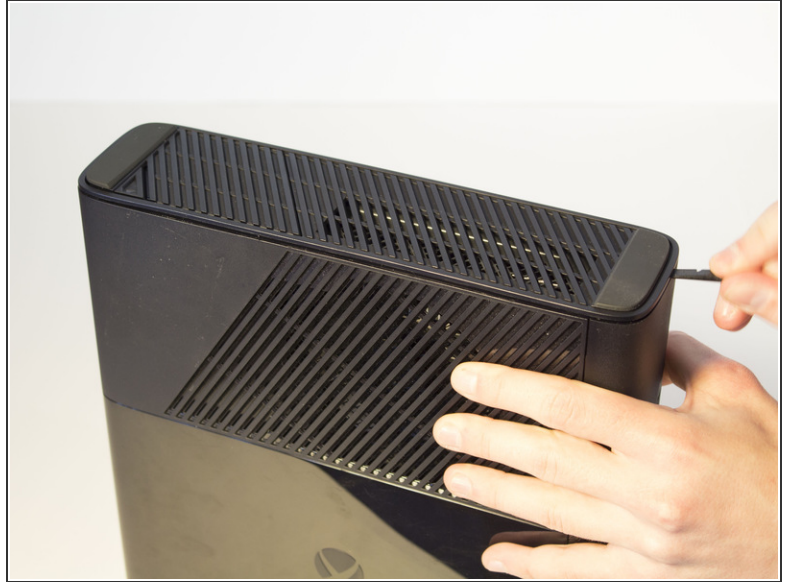
Step 5

- Slide the spudger along the crevice to separate the grated face and the top body.

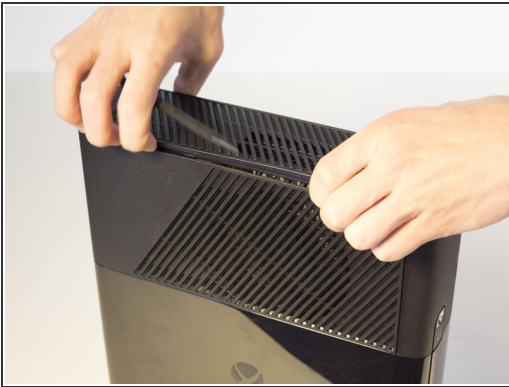
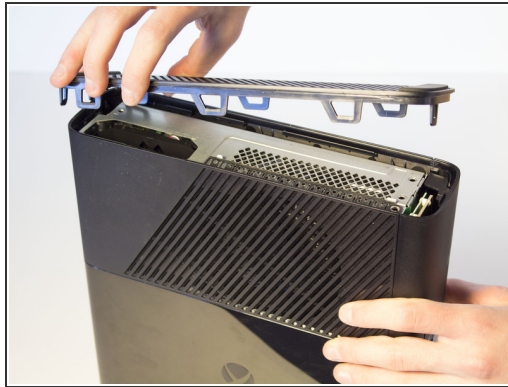
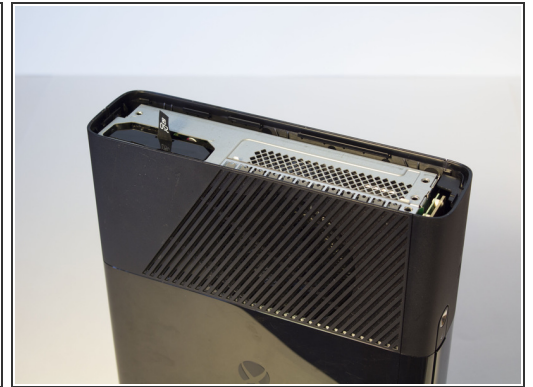
Step 6

- Wiggle the spudger in the crevice as you slide the spudger to loosen the bottom plate.
- Slide the spudger along the crevice, going completely about the perimeter of the bottom panel.
- Pull the bottom panel off.

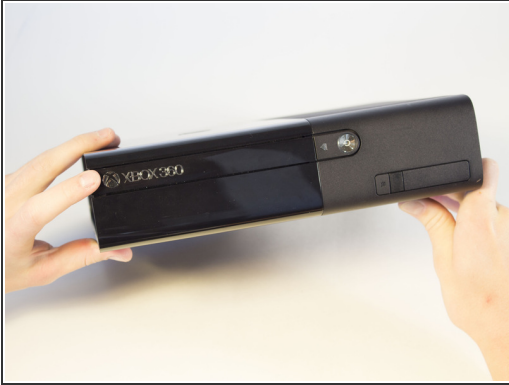
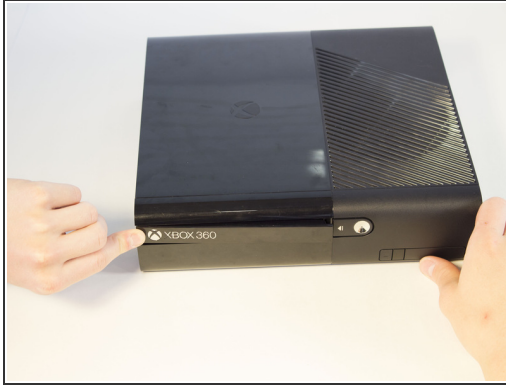
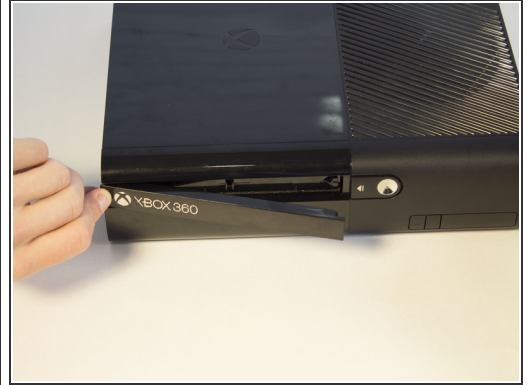
Step 7 — Front Panel

- In front of the CD drive you will find the Xbox logo. Press on the area left of the Xbox logo, and the disk tray panel will pop off.

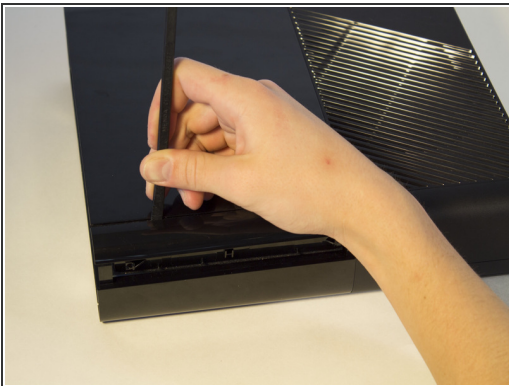
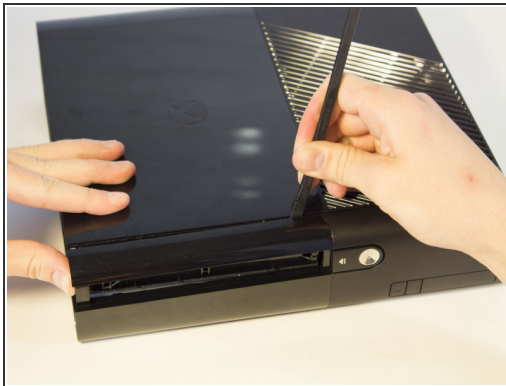
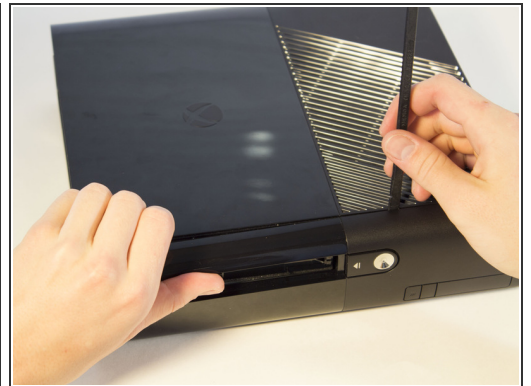
Step 8

- Beginning on the left side without the grate, run the spudger along the crevice until you've reached the grated part, while holding the part that's being separated as you go.

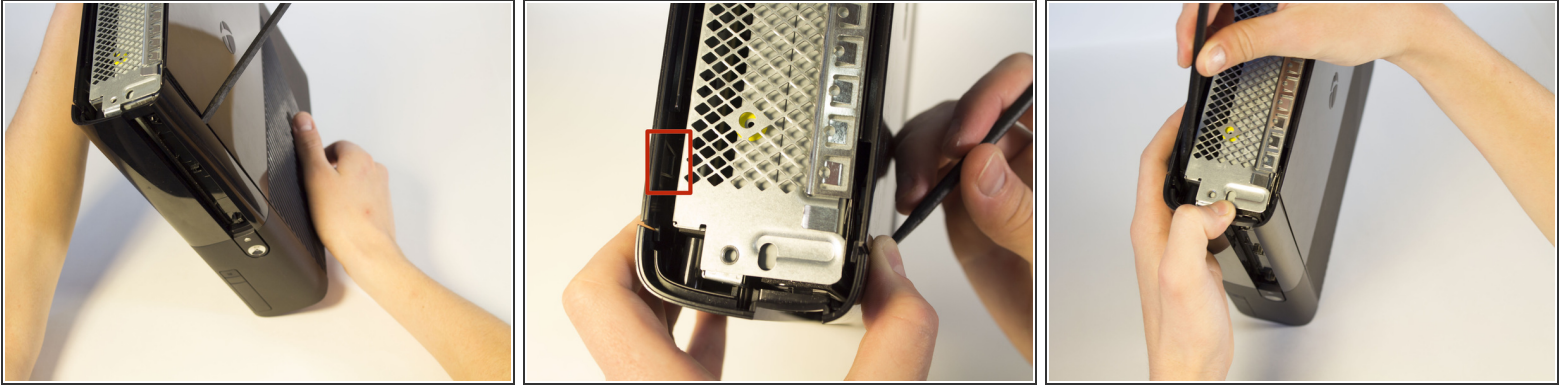
Step 9

- Keep holding the partially separated panel open. It's easiest to do this by wedging a spudger into the opening but can also be held open by your hands.
- Rotate the Xbox to the left to locate the clip connecting the front panel to the body. Insert the spudger inside the gap to release the clip. This may require wiggling the spudger. The clip will pop off, making the front panel looser.

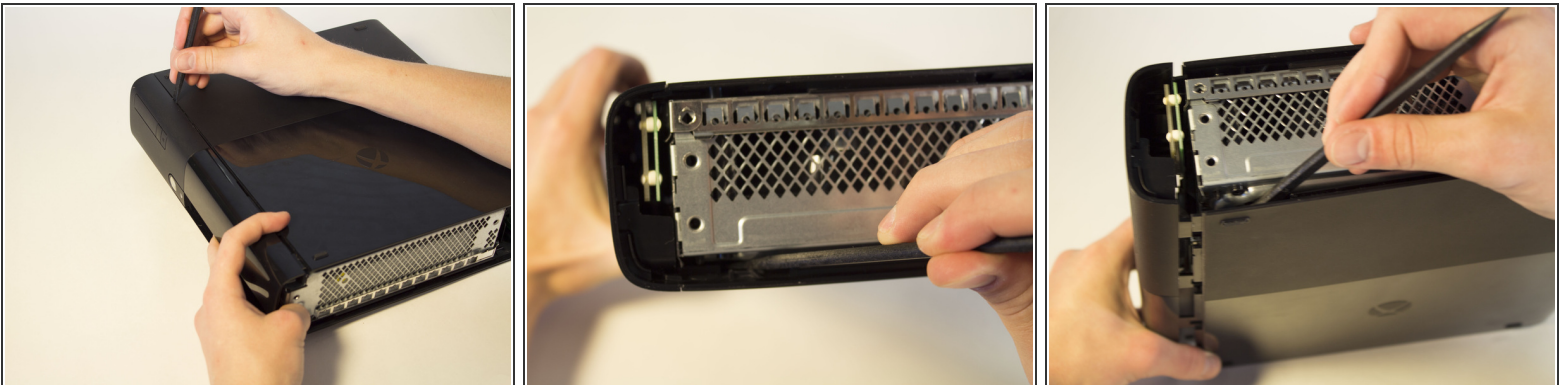
Step 10

- Flip the Xbox so the opposite side is towards you. Make sure to keep the separation open.
- Locate the other clip and insert the spudger to remove it.

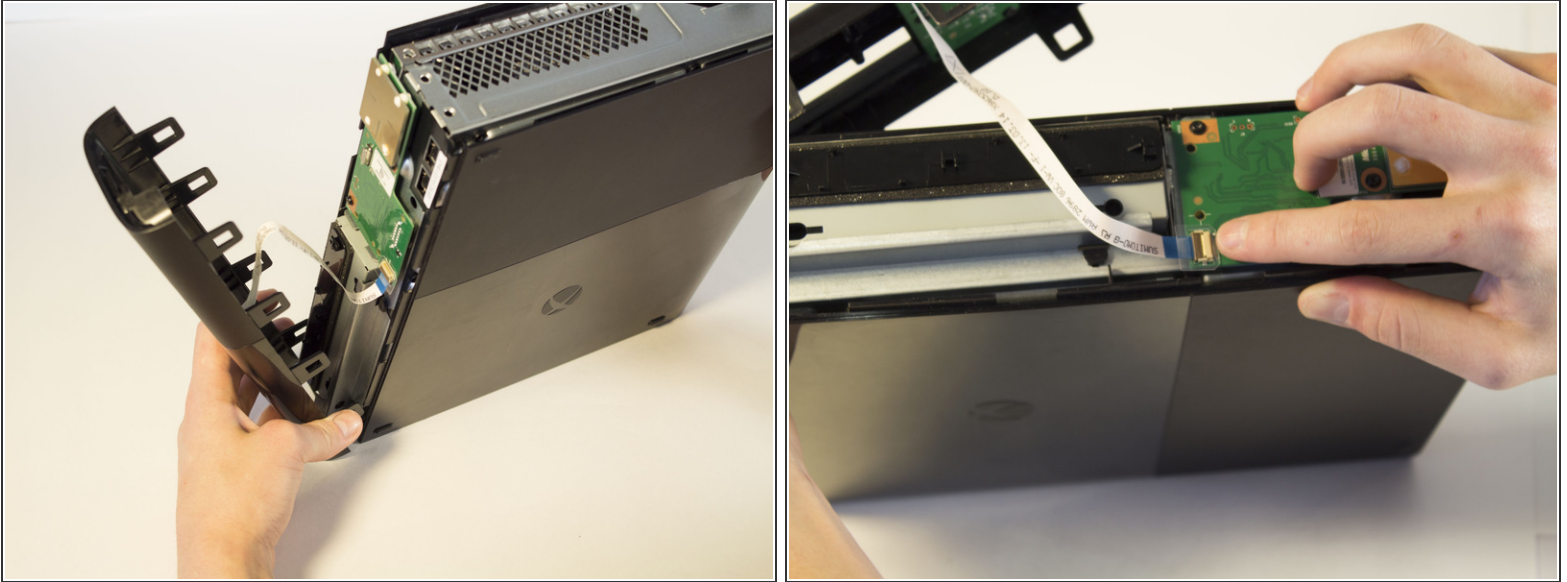
Step 11

- Continue to run the spudger along the crease to release any further clips that may still be attached.

Do not pull off the panel too fast because you don't want to damage the ribbon cable. Slowly pull away the panel.

- Now that the front panel has been released from its clips you can pull off the front panel.

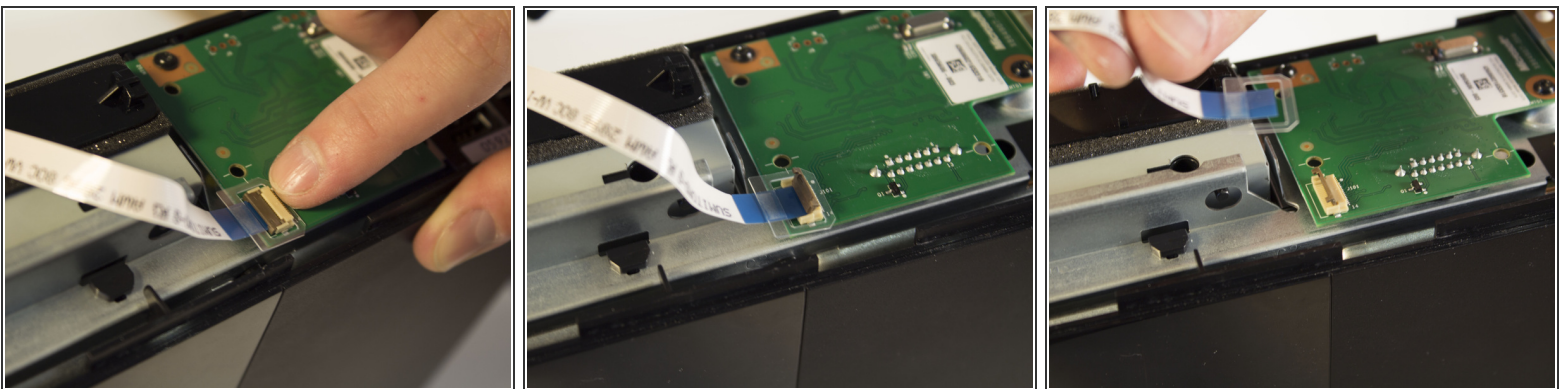
Step 12

- Find the brown section where the ribbon cable enters the green board. Flip the brown part up and pull out the plastic tab at the end of the ribbon.

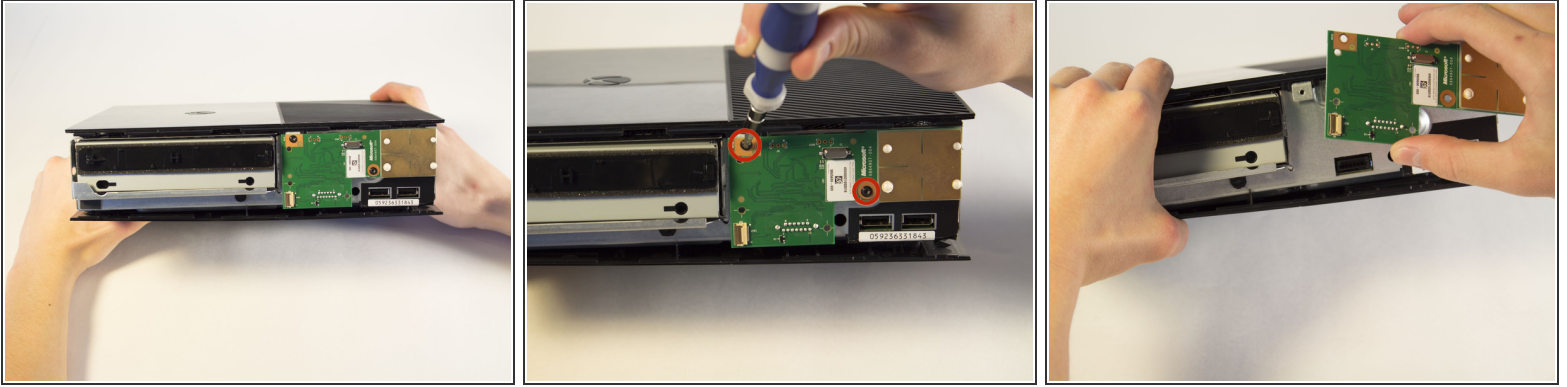
Step 13 — RF Module

- Looking at the body of the device, locate the green panel to the right of the CD drive.
- Remove the two 6 mm screws located on the top left and middle right with a T8 Torx screwdriver.
- Grip the middle of the green board and gently pull it out.

To reassemble your device, follow these instructions in reverse order.
